HP laptop v2000 dv1000 notebook power detail Step with timing

DV1000/V2000/ POWER ON DETAIL

V 2000/ DV1000/ M2000 MOTHERBOARD TRACING DETAIL

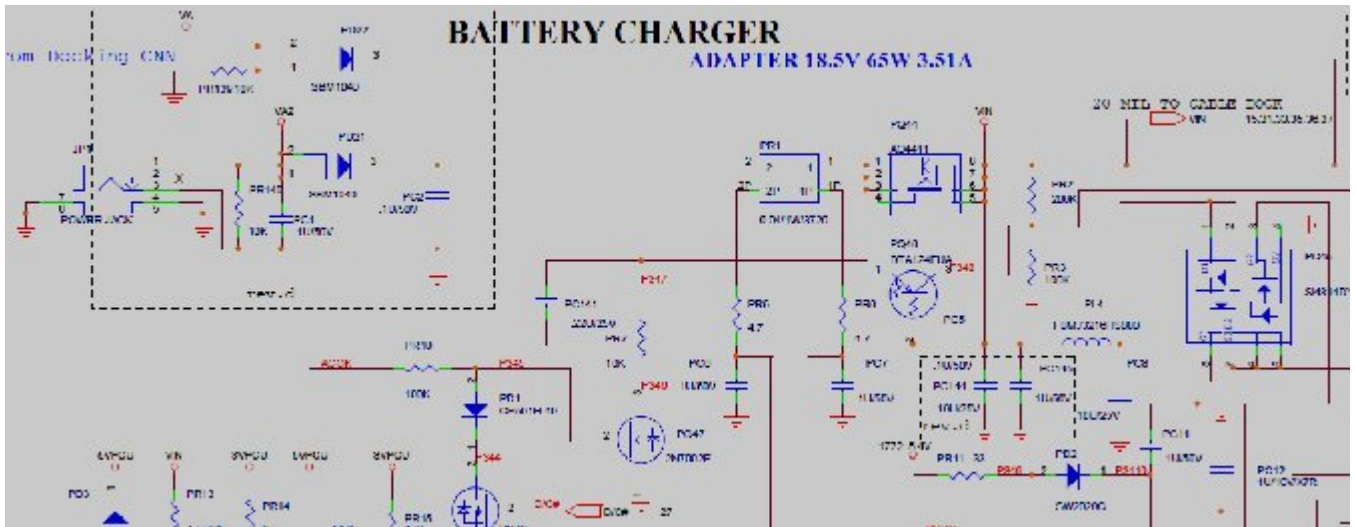
First Step is to check whether normal voltage VA is generated. (VA is the voltage through PJ1 Power Connector Adapter for Input Voltage.) If the Diode PD21, PD22 is open then VA voltage will not be generated in normal circumstance.

Second Step is to check whether the VIN voltage is normal. VIN voltage is the voltage from the VA conduction through the controlling MOSFET PQ44.

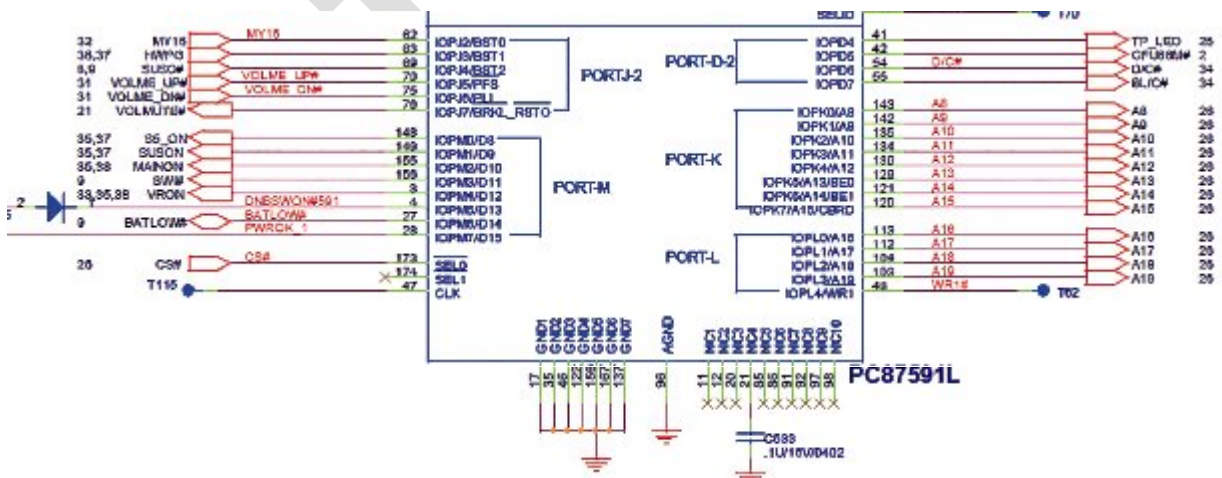
Sixth Step Check the power management chip to detect whether the first 4PIN (DNBSWON to South Bridge) instant boot button is pressed. A high to low negative pulse transition should be detected. If not, then this is an indication of trouble in the power management chip.

South Bridge received DNBSWON low, it occurs SUSB #, S USC # 2 high sent to 97551/87591, South Bridge chip part of the line is always in working condition. Likewise, it is also connected to a 32.768kHz Y5, its role is to South Bridge chip modules RTC and basic detection module reference clock.

Southbridge chip power management chip receiving the boot action to issue a pulse signal, this chip will be the first 26PIN the S USB #, the first 69PIN high of SUSC # set to an invalid state, the power management chip, boot up action to provide necessary conditions. parts.

South Bridge chip part of the line is always in working condition. Likewise, it is also connected to a 32.768 kHz external when Zhong Jingzhen Y5, its role is to South Bridge chip modules RTC and basic detection module reference clock.

Southbridge chip power management chip receiving the boot action to issue a pulse signal, this chip will be the first 26PIN the S USB #, the first 69PIN high of S USC # set to an invalid state, the power management chip, boot up action to provide necessary conditions.
